NC PV DG Program SEPA Presentation

PV Solar Rooftop Incident

Incident: PV Solar Fire

Where: Rooftop of Manufacturing Facility in Mount Holly, NC

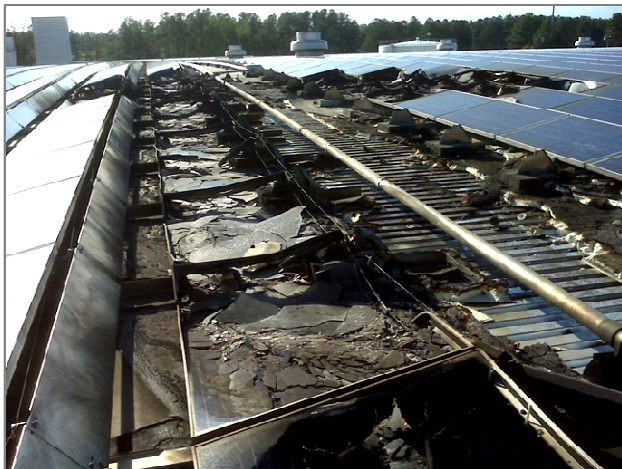
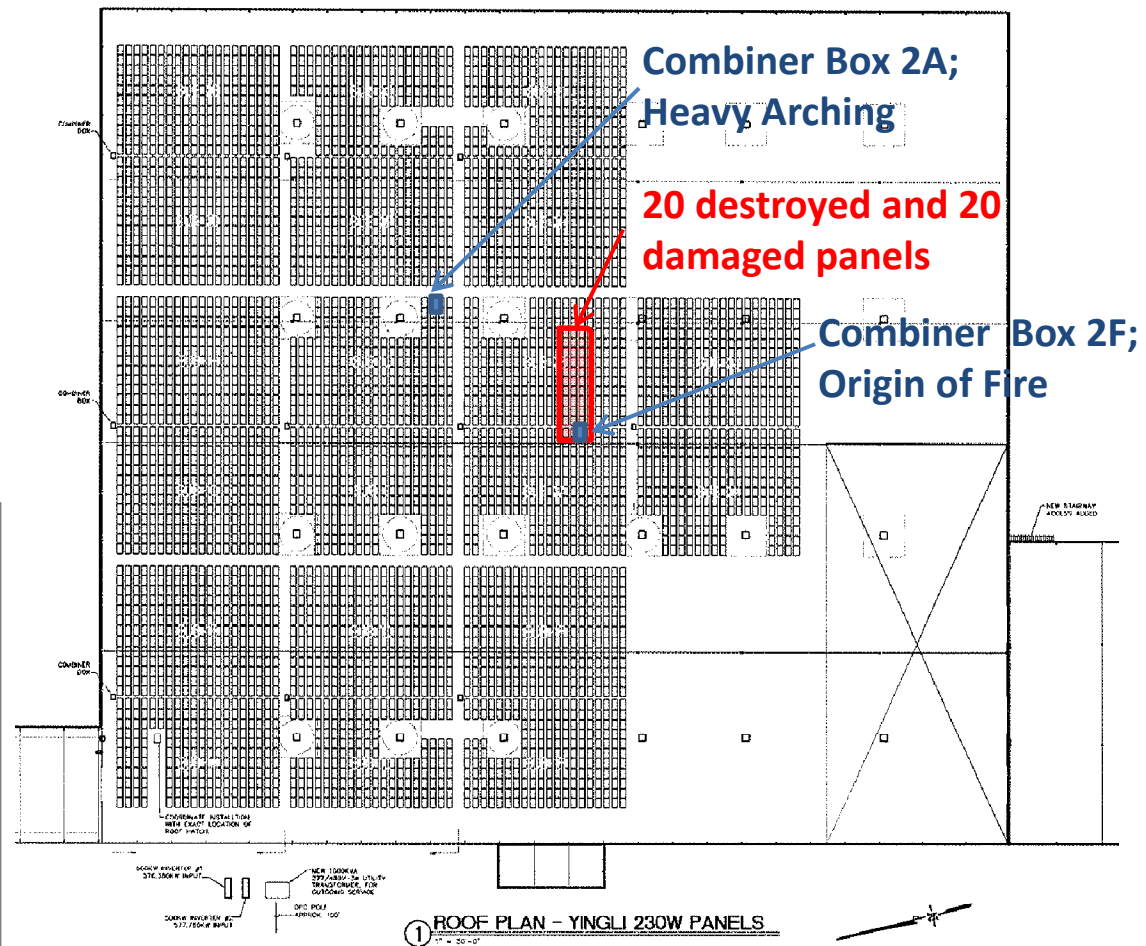
What: Fire damaged or destroyed solar panels, combiner box 2F (fire), combiner box 2A (arching), and roofing.

5,252 230-Watt PV modules; Two inverters 500 kW inverters and one 135 kW inverter.

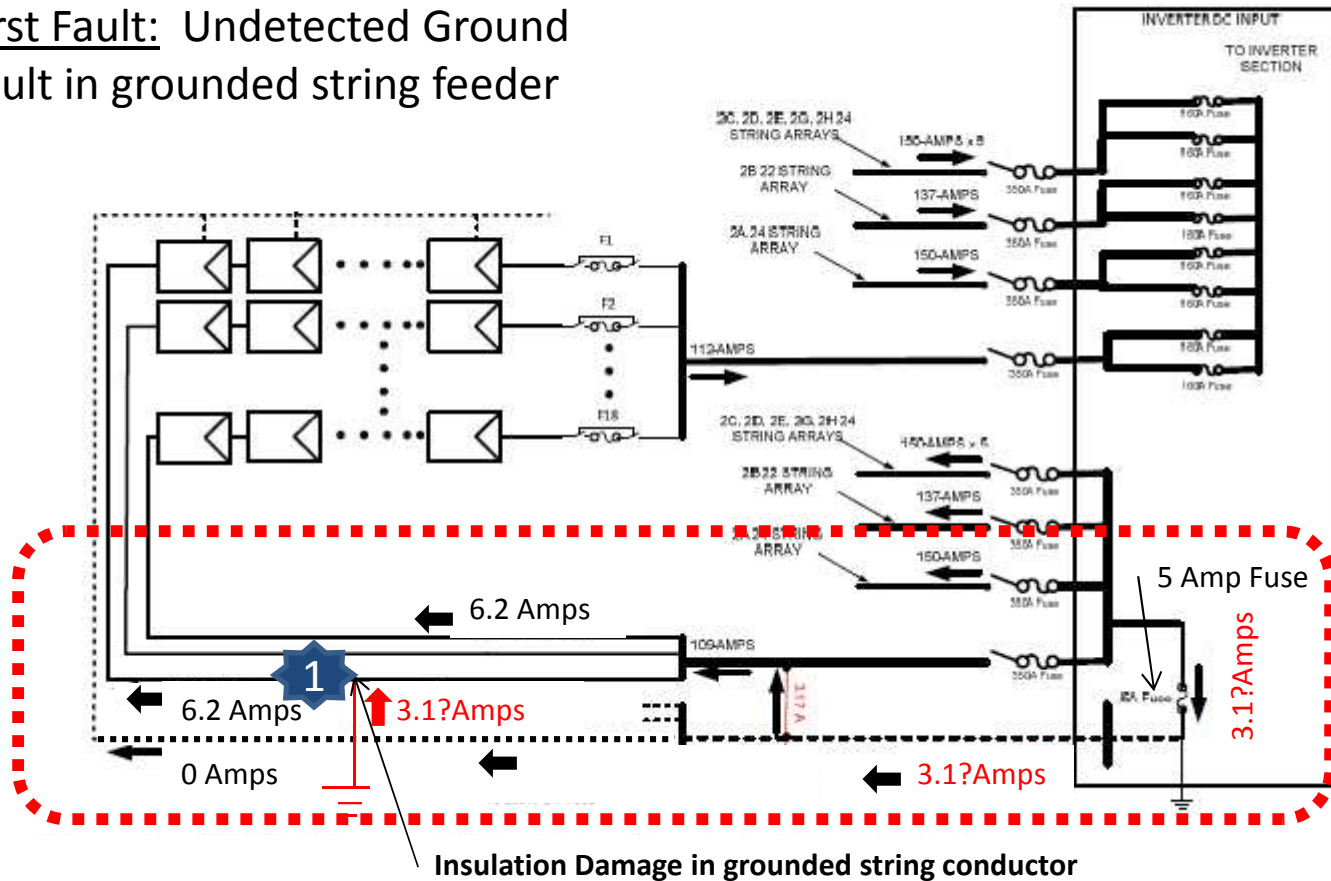
First Fault: Undetected Ground Fault in grounded string feeder

- **PV System Protection Design**: A low level ground fault (below 5 amps) is not detected with the GFP located in the inverter...aka the “Blind Spot”
- **Undetected grounded feeder conductor (2F) fault**: A string feeder (2F) ground fault occurred at an unknown time. Only a portion of the string operating current was directed toward the inverter through the ground. It was at a level insufficient (less than 5 amps) to be detected . As a result , the inverter did not trip.

A Ground fault in ungrounded string feeder (normally operating between 6 to 8 amps) can be too low to be detected by the GFP in the inverter when current is split between the feeder and ground (3 to 4 amps).

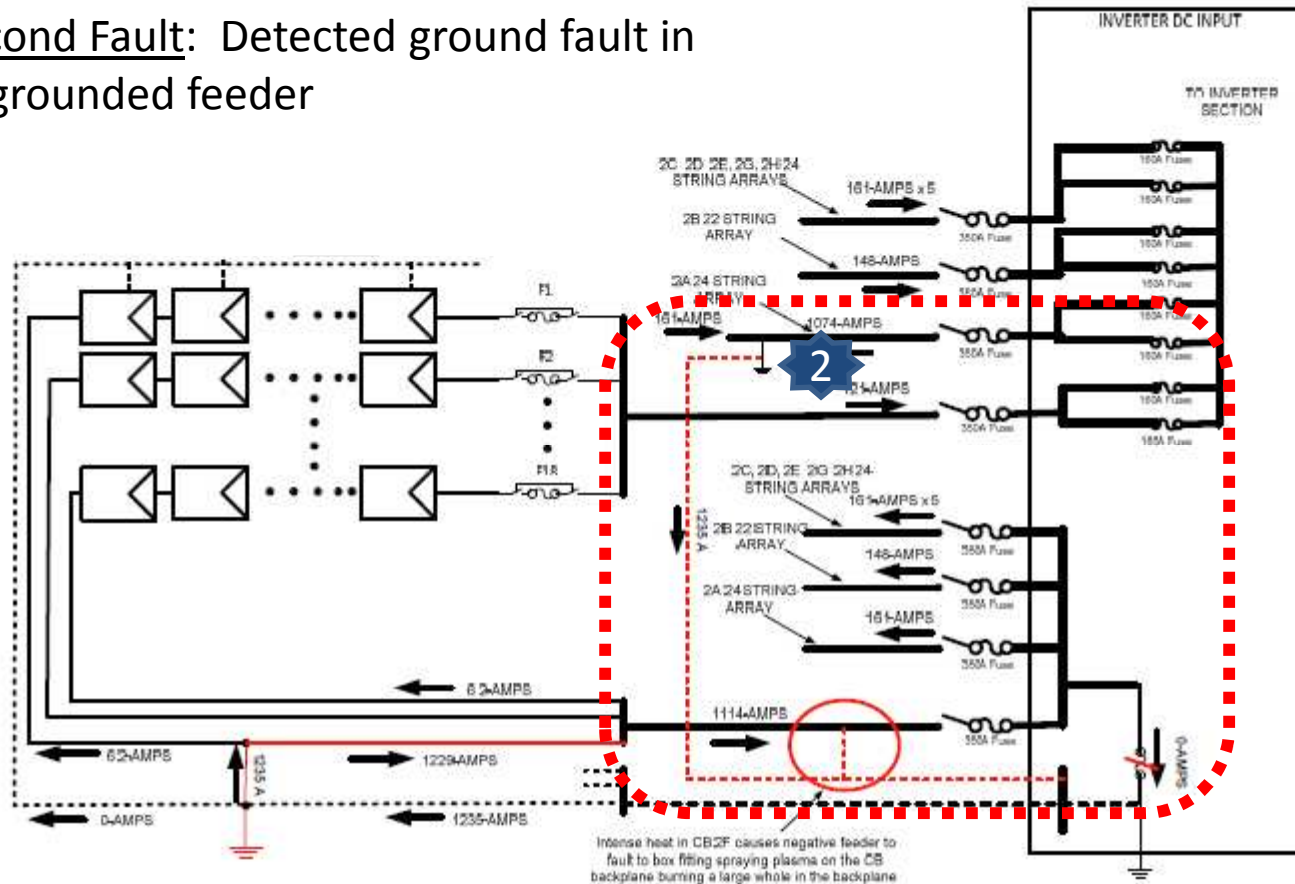
Second Fault: Detected ground fault in ungrounded feeder

- **Second ungrounded string conductor (2A) fault**: A second ground fault on an ungrounded conductor (2A) occurred in a feeder that was connected to the same inverter. Arcing marks were identified where this feeder connected to the combiner box. The current in the ground from the second fault was large enough to trip the GFP. This current flow then went back trough the ground fault connection made by the first ground fault. This current exceeded that rating of the string feeder and associated equipment. This caused these component to be heated to the point of combustions.

If second fault occurs in an grounded feeder, all current flowing to the inverters (1235 amps) from all of the combiner boxes can be re-routed to the ground and string conductors when GFP trips.
