Ground Fault Protection Improvements to Prevent Fires

Description of problem
and potential solutions

Bill Brooks, PE

Ground-Fault Protection Blindspot

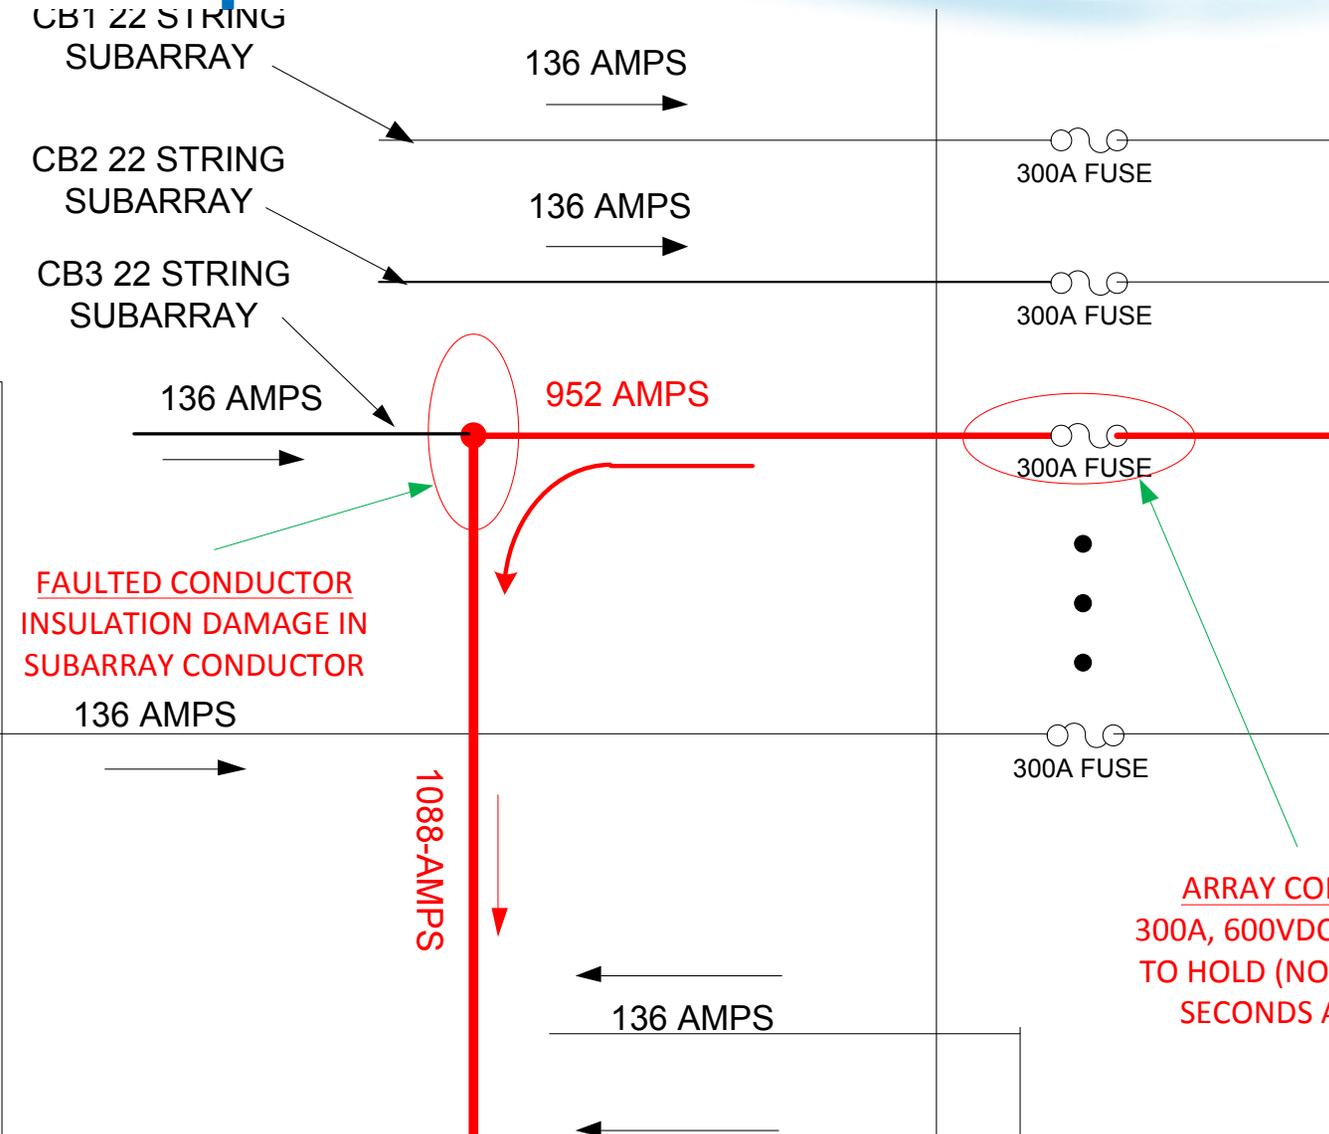
**FAULTED CONDUCTOR
INSULATION DAMAGE IN
SUBARRAY CONDUCTOR**

**ARRAY COMBINER FUSE
300A, 600VDC FUSE DESIGNED
TO HOLD (NOT CLEAR) FOR 60
SECONDS AT 952-AMPS.**

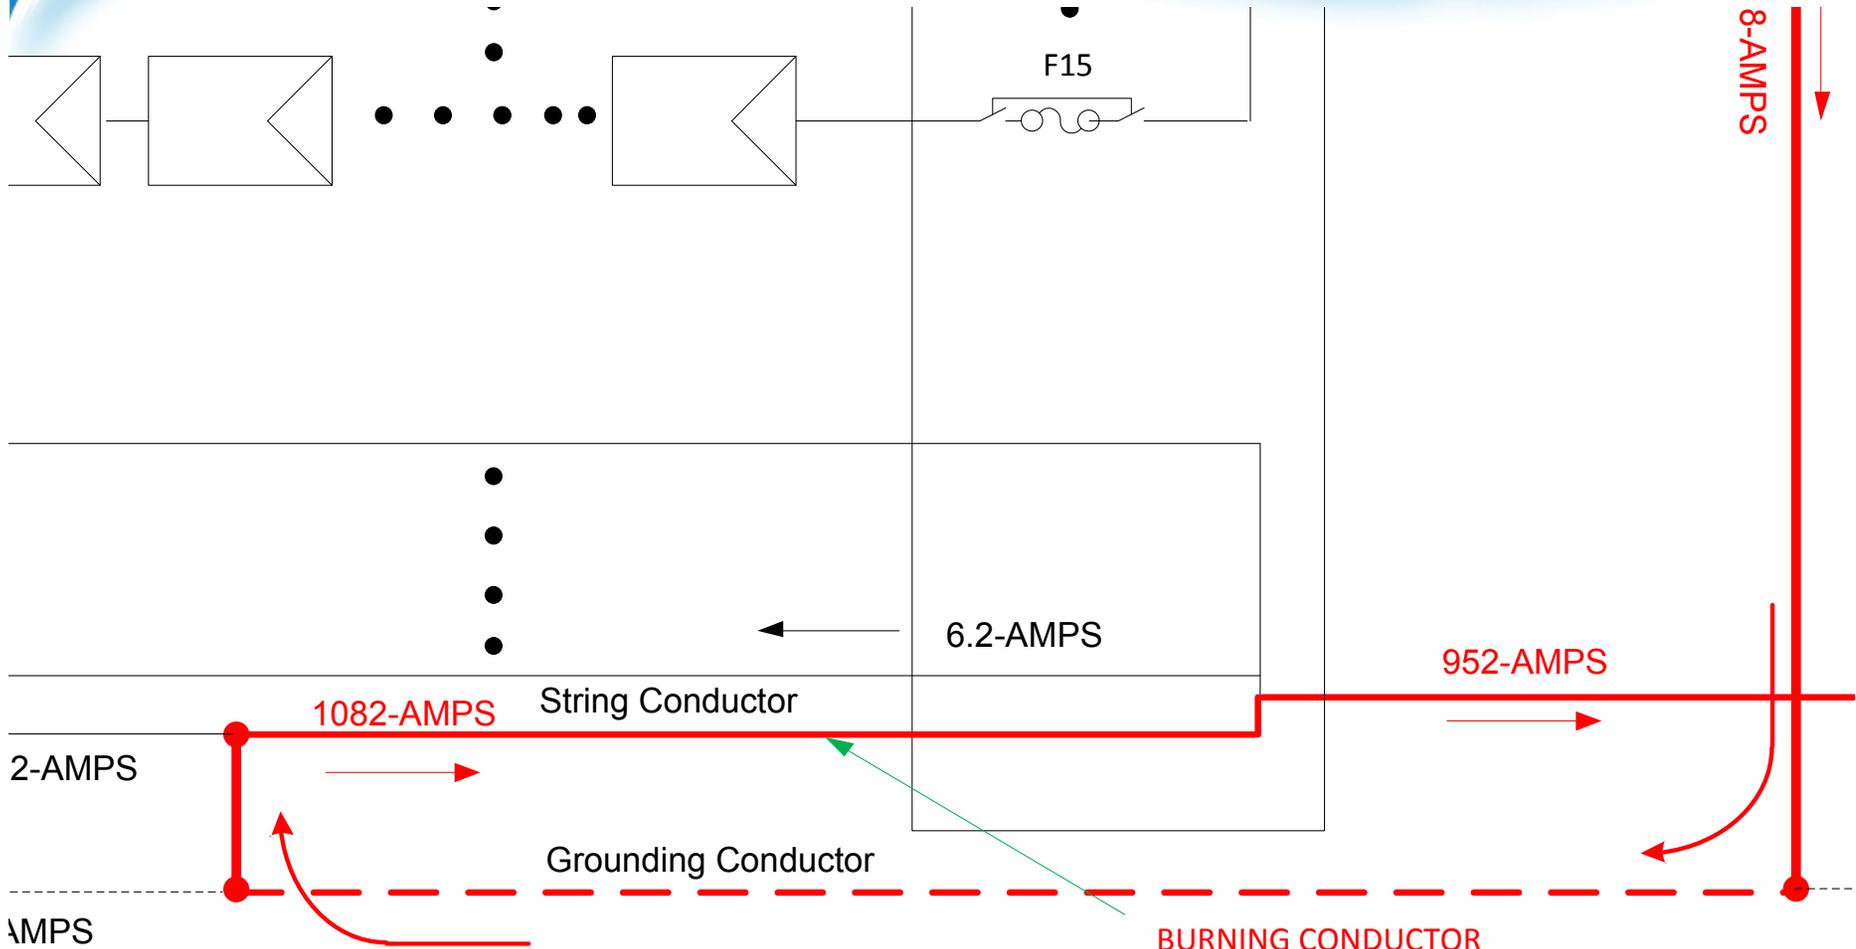
BURNING CONDUCTOR
INSULATION ON 10AWG CONDUCTOR IGNITES AT HIGH CURRENT IGNITING MODULES AND OTHER NEARBY FUEL

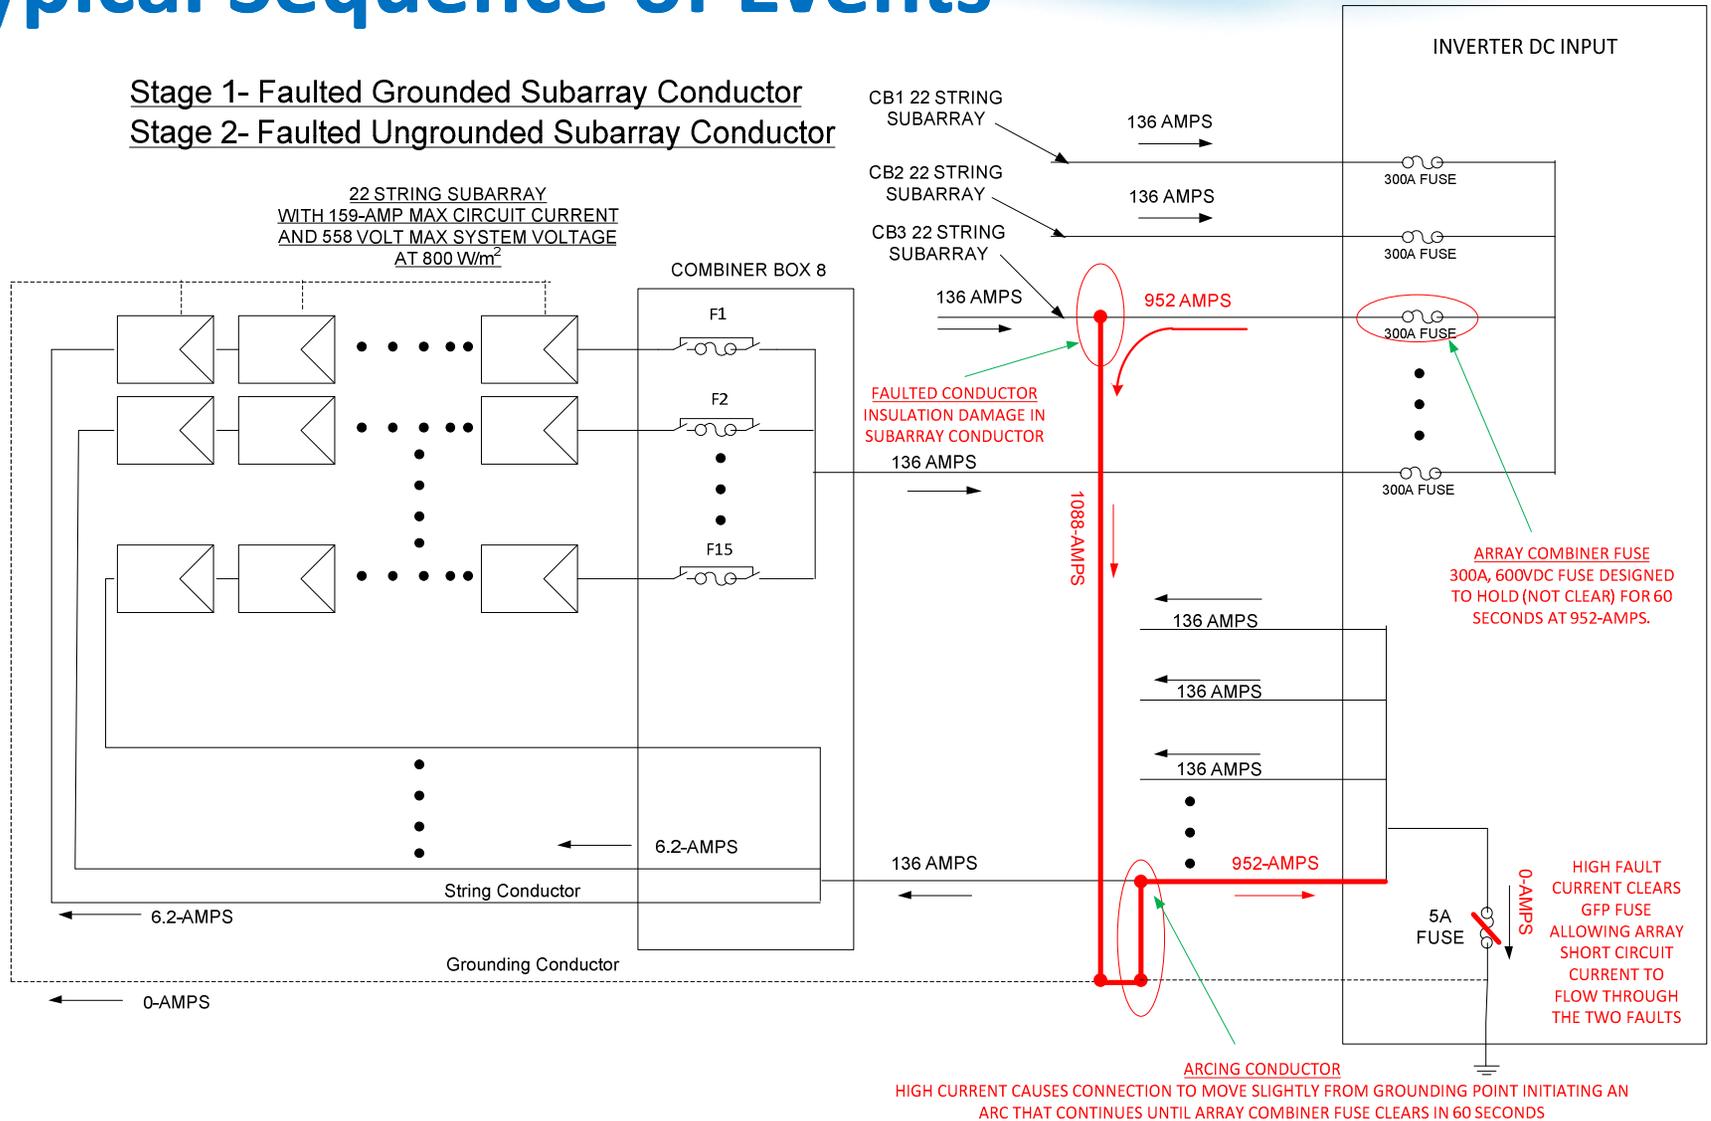
Stage 1- Faulted Grounded Subarray Conductor
Stage 2- Faulted Ungrounded Subarray Conductor

HIGH FAULT
CURRENT CLEARS
GFP FUSE
ALLOWING ARRAY
SHORT CIRCUIT
CURRENT TO
FLOW THROUGH
THE TWO FAULTS

HIGH CURRENT CAUSES CONNECTION TO MOVE SLIGHTLY FROM GROUNDING POINT INITIATING AN ARC THAT CONTINUES UNTIL ARRAY COMBINER FUSE CLEARS IN 60 SECONDS
