# Ground Fault Protection Improvement Study

Greg Ball  
BEW Engineering (DNV-KEMA)

Solar ABCs Stakeholder Meeting  
September 14, 2012  
Orlando, FL

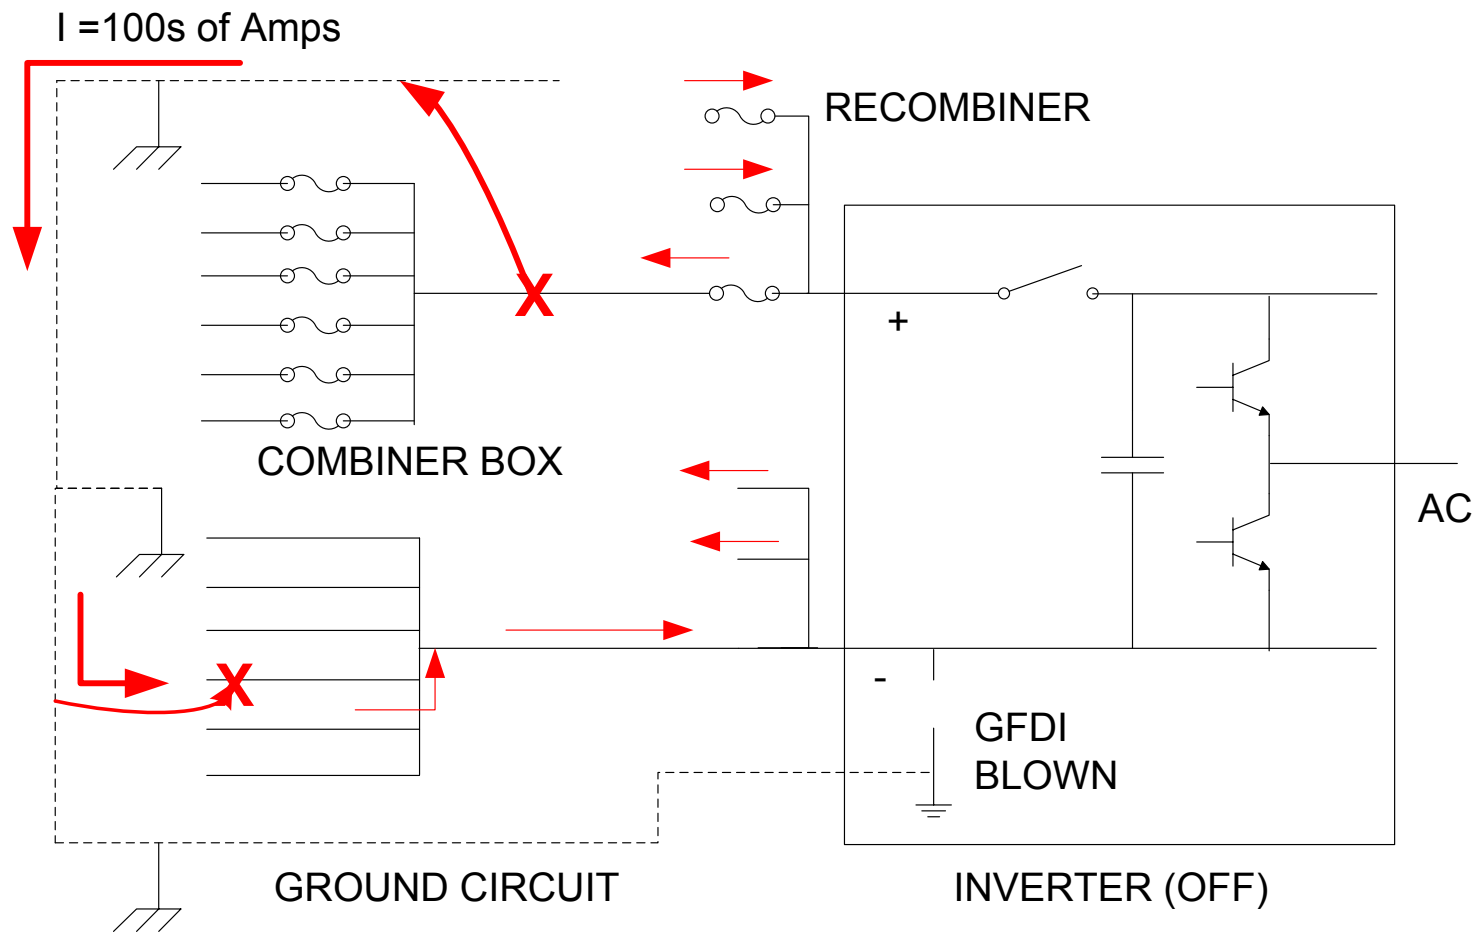
# Sustained fault, arcing and fire

## Protection by-passed

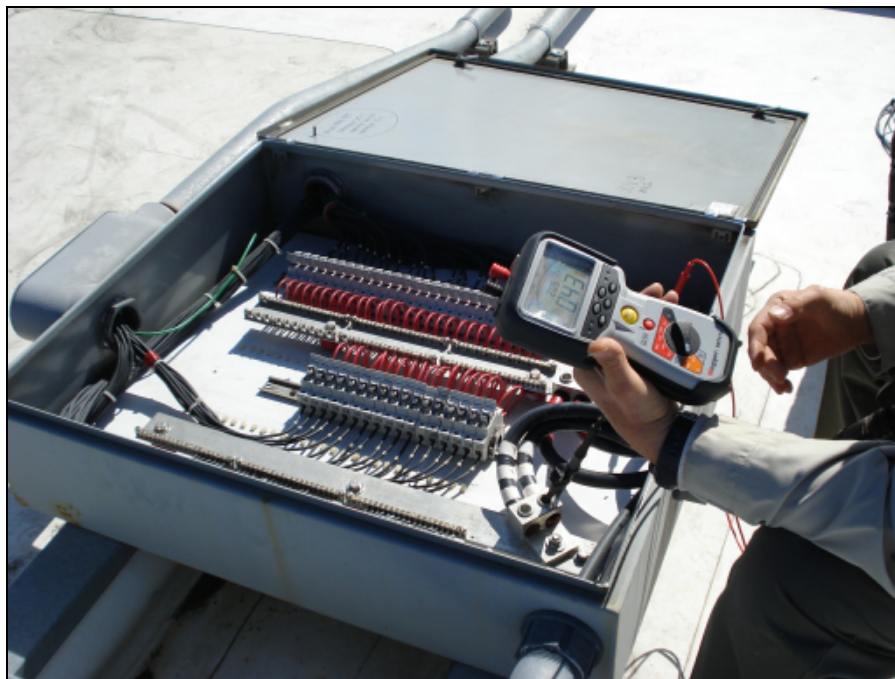
# Ground-fault test equipment

Ground-Fault Tester  
10, 5, 1 and 0  $\Omega$  settings
