Arc Detector for Remote Detection of Dangerous Arcs on the DC Side of PV Plants

Heinrich Häberlin

**International workshop
"Arcing in Photovoltaic DC-Arrays – Potential Dangers and
Possible Solutions",
October 31st in Burgdorf/Switzerland**

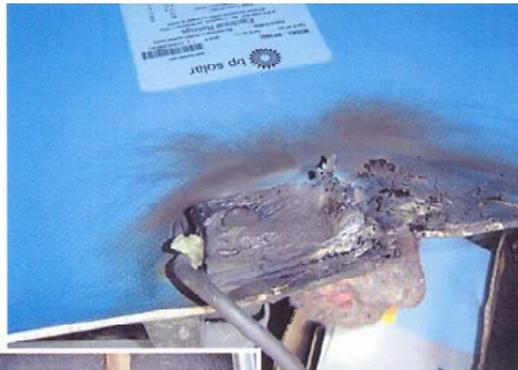
PV module and roof support structure damaged by smouldering fire caused by a DC arc in a module connector box

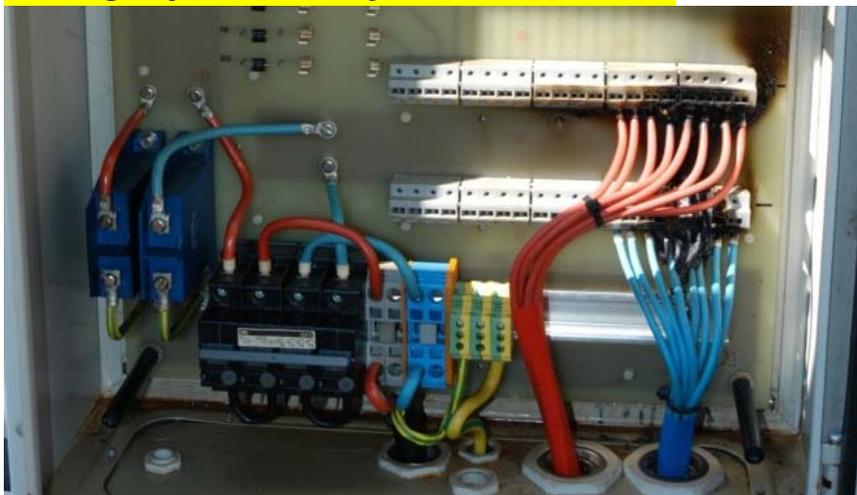
Damage caused by a smouldering fire, which occurred in the connector box of an 11 year old PV plant (15kW) in Burgdorf.

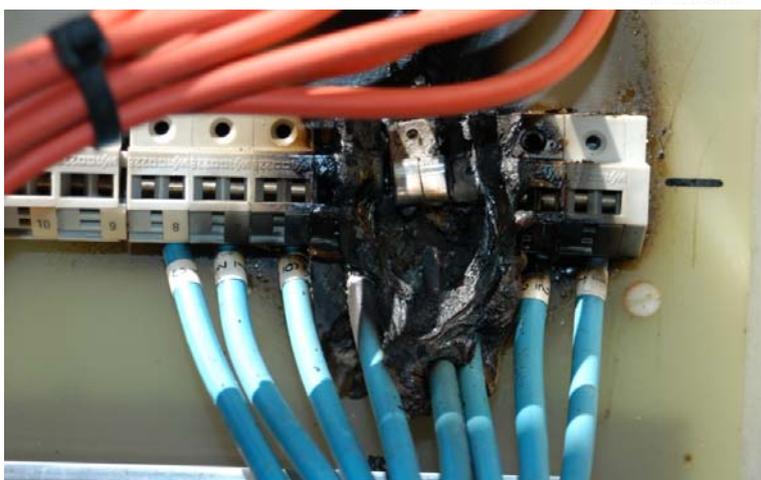
Close-up view of the origin of the fire. A soldering point on the PC board or a connection gradually warmed up and finally melted, developing an electrical arc causing the fire (V_{MPP} was about 500V).

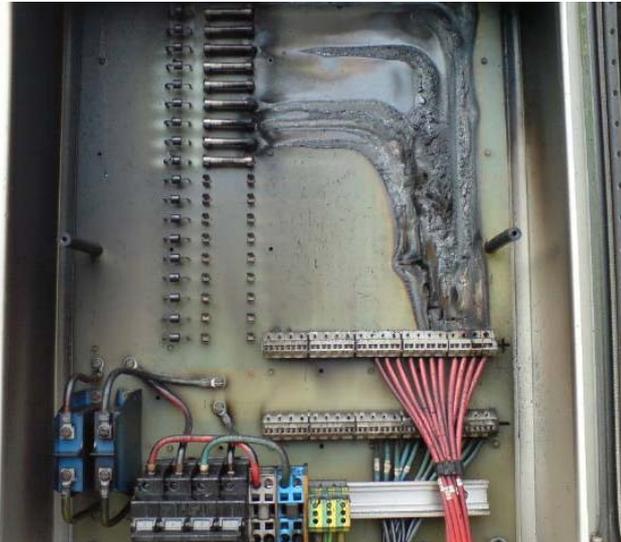
PCB tracks already charred by series arcs in an array connector box of a similar PV plant of 20kW (V_{MPP} about 500V) immediately after opening of the cabinet. In this condition, the PV power was already very much reduced.

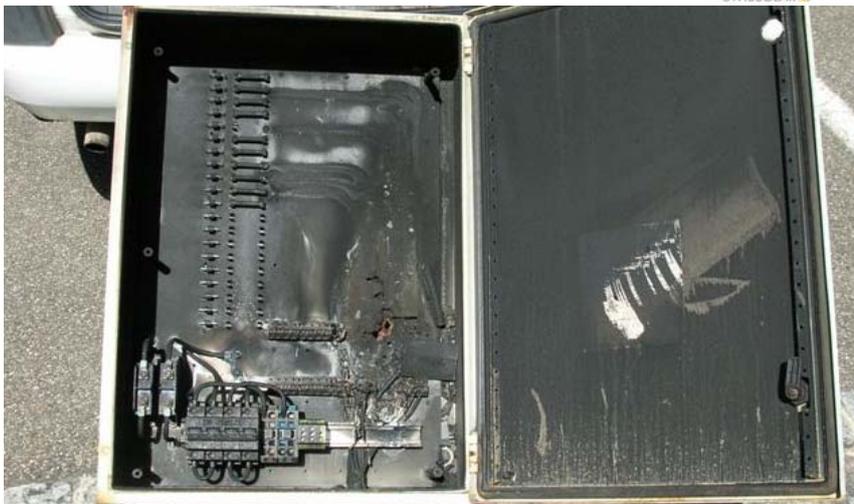
After opening, additional oxygen could enter the cabinet and a catastrophic fire occurred that destroyed the cabinet completely.

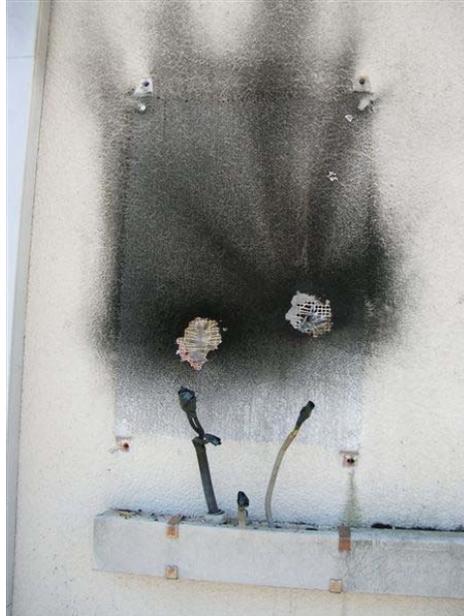
Damage at the outer wall (with external thermal insulation) of the building, on which the connector box was mounted. The arc in the cabinet even melted a hole through the back wall of the metal cabinet!
(Source of picture: EBL)

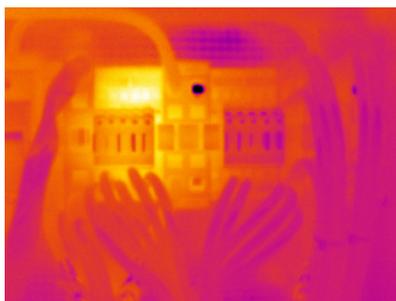
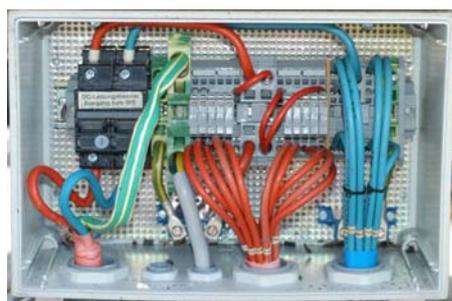
At a PV plants with a lower V_{MPP} of about 100V, a connector that joins the two halves of the array in the middle of the connector box burned and caused an interruption (see thermographic picture at left, repaired connector box with wires replacing the defective connectors at right). Due to the lower V_{MPP} , no arc and no fire has occurred in this case.

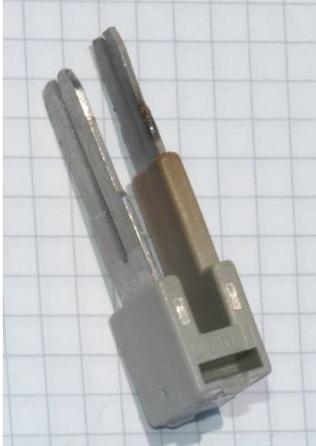
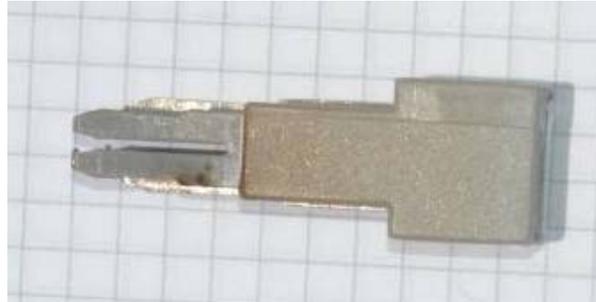
Bridge connectors with damaged (slightly burned) contacts that were used to join the two halves of the PV array in the middle of the array connector box. In this case, due to the low voltage available to sustain the arc (about $0.2 V_{MPP}$), no arc occurred.

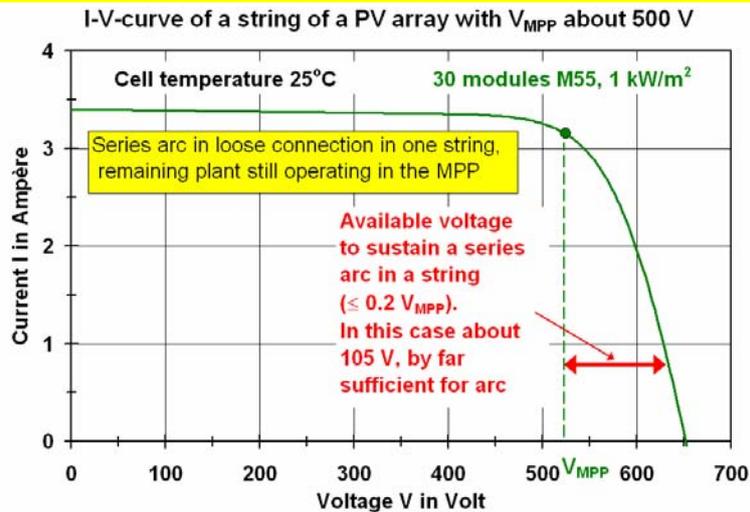
Explanation for observations in the field

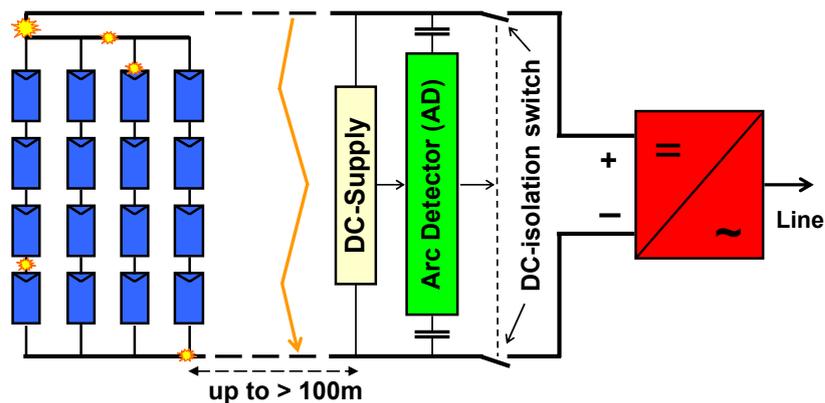
When an electrical arc occurs on the DC side, in a *combination of two resonant circuits* a high-frequency signal is detected. After certain checks the isolation switch is activated and the DC side of the inverter is disconnected.

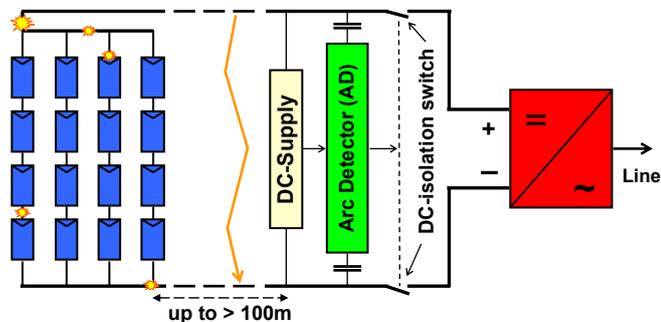
- Production of 12 *autonomous* prototypes (fed directly from PV plant) and field test (in CH, D + I) 1996 – 1998.
- ADs can detect arcs over distances of 100 m to 200 m, if the inverters do not produce excessive RF voltages on their input lines on the DC side.

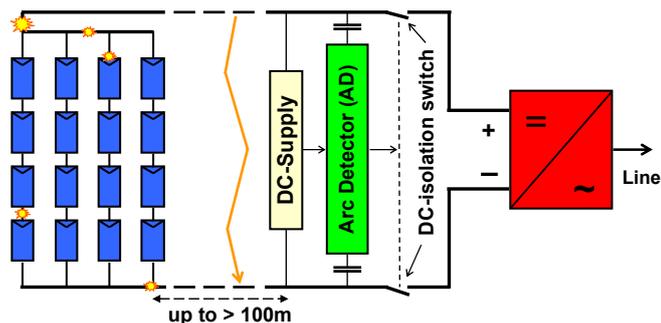
- Sometimes problems due to high RF voltages on the DC side \Rightarrow sometimes additional filters were necessary.
- With some inverters erroneous detections during start-up.
- First patent application dropped due to lack of interest from the PV industry (still small then).

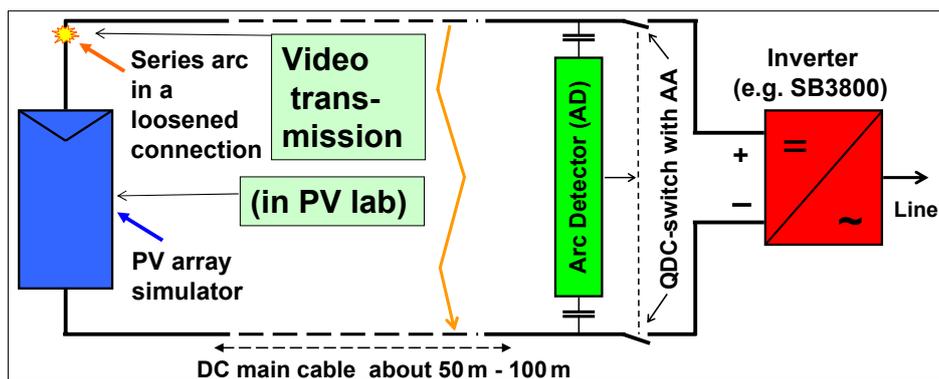
Upon recognition of a series arc in the loosened connection, the arc is interrupted by means of an electromechanical QDC switch.

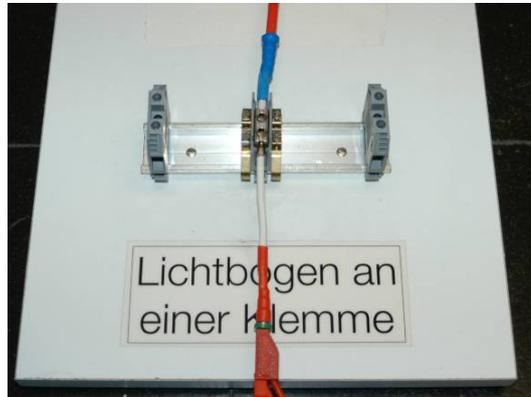
The plus-connection of the cable to the AD and the inverter is passed across a connection that can be loosened.

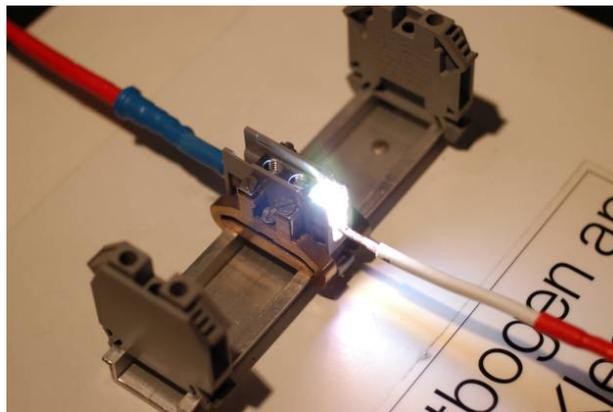
With a loosened connection an arc occurs, which is recognised by the AD and switched off immediately.

Note: In order to obtain a nice long arc looking dangerous, the AD was disabled for a short time for this picture!

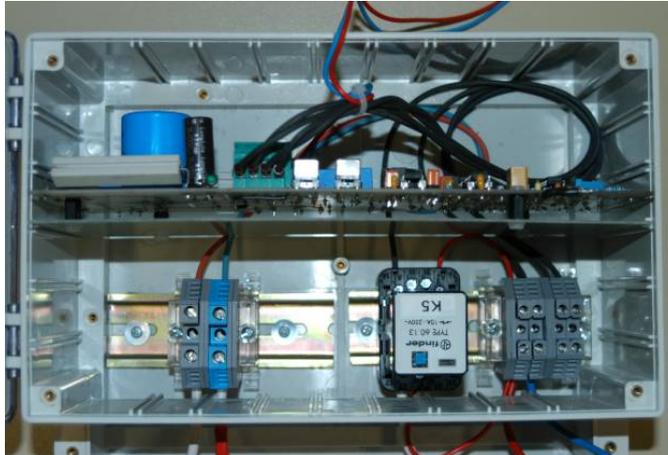
The arc detector (AD) with IDU which was used for these tests performed in autumn 2006 was composed of parts that were still available from earlier projects. Many parts were used that would not be needed for an AD integrated into an inverter.
